Lessons Learned Report

2020-01 – Towline Chaffing/Breaking

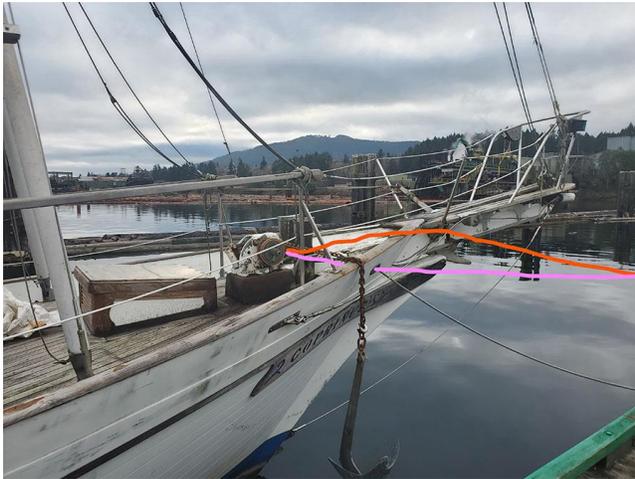
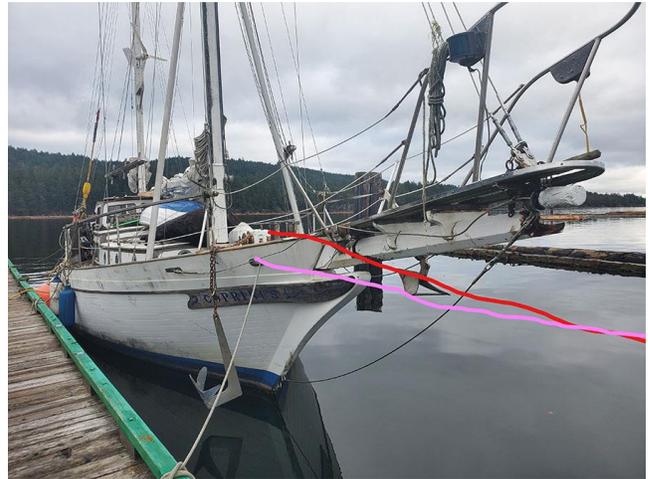
Shortly after paying out about 180 feet of tow line, the tow line severs, and goes slack in the water. A crew member is put on board to assist in comms and assess towline. Examination of the towline indicates it was worn through about 1 meter from the eye loop likely from the bowsprit of the stricken vessel. Tow set up reassessed, and vessel taken under astern tow again by attaching RCMSAR towline to a heavy line provided by the stricken vessel and fed through the starboard bow hawse hole to help alleviate further chaffing. RCMSAR crew member remained on sailing vessel to assist in steering, tow watch, and comms in following seas.

About an hour later approximately 2 cables SE of the safe harbour, towline severs again. Examination of the tows revealed the line parted in a similar fashion to the initial tow. As they were so close to the harbour, and alongside tow set up was completed in preparation for docking and approach to harbour. Stricken vessel secure at dock and RCMSAR crew RTB.

Red Line – Initial CCG/RCMSAR tow set-up. Pink Line – Secondary tow set up after line severed

- 3) Alternative tow set up and/or anti-chaffing gear were not considered/used initially. When rigging the second tow, the Coxswain decided the sea state was too unsafe to attempt a bridle set-up. Had the CCG crew on board the stricken vessel been asked to assist before crew transfer and release of the CCG towline initially, a bridle set-up could have been considered in a slightly more moderate sea state, and likely would have alleviated line chaffing/severing throughout the tow.
