Lesson Learned Report 2011/10

Structural Failure on Arches

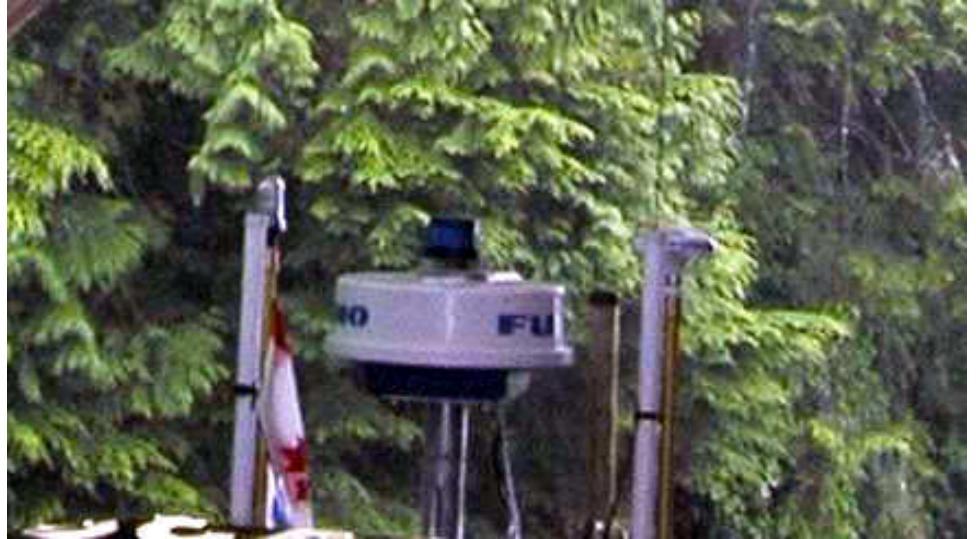
1. In the first the radar scanner was mounted on a single tube rising vertically from a plate welded to the rear horizontal tube, aft of the rerighting bag.

The scanner was lost overboard, and use of the radar was lost.

All stations with arches on their vessel are reminded to closely inspect the whole arch structure on their vessel, from its attachment to the deck, to where it is bracketed off the transom, and all appendages to find cracks or wear at an early stage, and get them repaired.

In particular close attention should be paid to cracks forming on or immediately adjacent to welds on the structure, or on any formed curves, especially on the side in tension.

This inspection should take place at monthly intervals, and after every outing in rough weather.

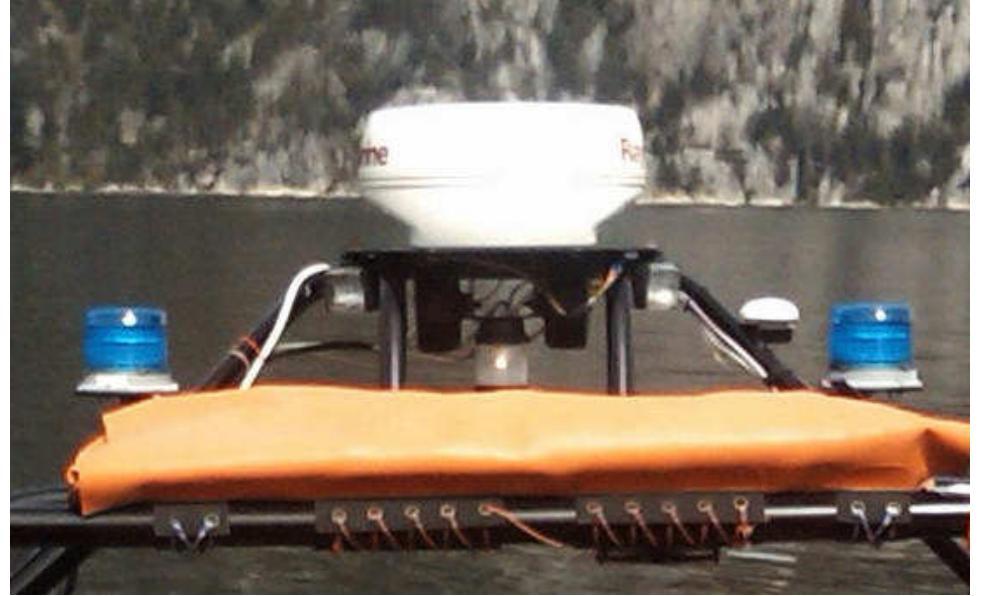
2. In the second the radar scanner, and GPS antenna were mounted on a subframe mounted off the rear of the arch.

This resulted in the loss of the use of the radar and the GPS and thus the plotter.
