Lessons Learned Report

2020-01 – Towline Chaffing/Breaking

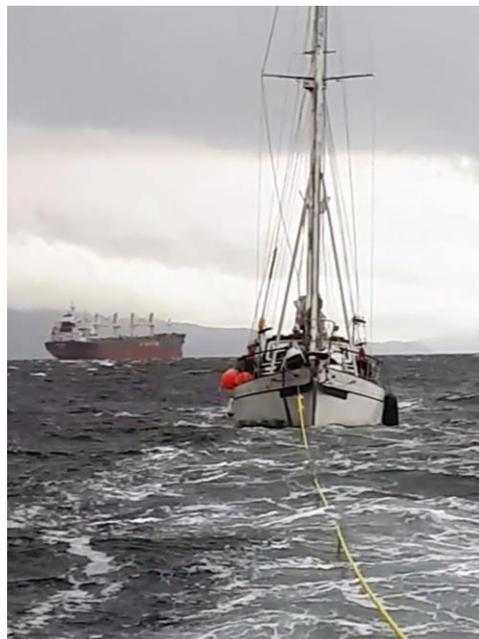
Shortly after paying out about 180 feet of tow line, the tow line severs, and goes slack in the water. A crew member is put on board to assist in comms and assess towline. Examination of the towline indicates it was worn through about 1 meter from the eye loop likely from the bowsprit of the stricken vessel. Tow set up reassessed, and vessel taken under astern tow again by attaching RCMSAR towline to a heavy line provided by the stricken vessel and fed through the starboard bow hawse hole to help alleviate further chaffing. RCMSAR crew member remained on sailing vessel to assist in steering, tow watch, and comms in following seas.

Red Line – Initial CCG/RCMSAR tow set-up. Pink Line – Secondary tow set up after line severed

- 3) Alternative tow set up and/or anti-chaffing gear were not considered/used initially. When rigging the second tow, the Coxswain decided the sea state was too unsafe to attempt a bridle set-up. Had the CCG crew on board the stricken vessel been asked to assist before crew transfer and release of the CCG towline initially, a bridle set-up could have been considered in a slightly more moderate sea state, and likely would have alleviated line chaffing/severing throughout the tow.

- RCMSAR vessels should consider carrying anti-chaffing equipment that can be used during a tow if tow set up/conditions require. A simple idea for a line protector can be a piece of firehose as shown below.
